TWEEN BRIDGE INTERNAL DRAINAGE BOARD

Thorne, Crowle and Goole Moors SSSI Water Level Management Plan

May 2010

FINAL REPORT

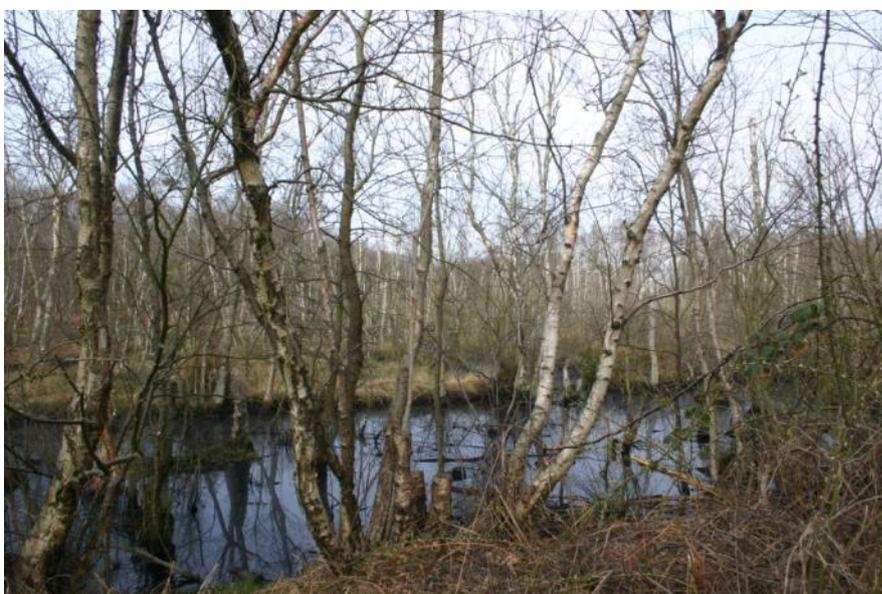
Figure 3-2 Area of Inundated Birch Woodland on the Eastern Boundary of Crowle Moors

Birdsall's (2000) work has implications for water management on Thorne. It suggests that the removal of heather and birch scrub is important in reducing the water loss from the site. However, if the watertable is regularly lower than 60 cm below the surface (cmbgl), then the water supply is the most important factor on the rate of evapotranspiration and the vegetation cover has little influence. This means that, in the driest areas, works such as ditch blocking should take precedence over scrub clearance (until the water levels are sufficiently high for clearance to have an effect) or these should be undertaken together. In the wettest areas, (where the watertable is stable above 20 cmbgl) where birch and heather still occur, scrub clearance is not required to maintain a high watertable. In fact the high watertable is likely to inhibit the growth of scrub and result in a reduction in their land cover. This effect should be noted in woodland areas which have been inundated by high water levels, such as those on the eastern boundary of Crowle Moors (Figure 3-2).

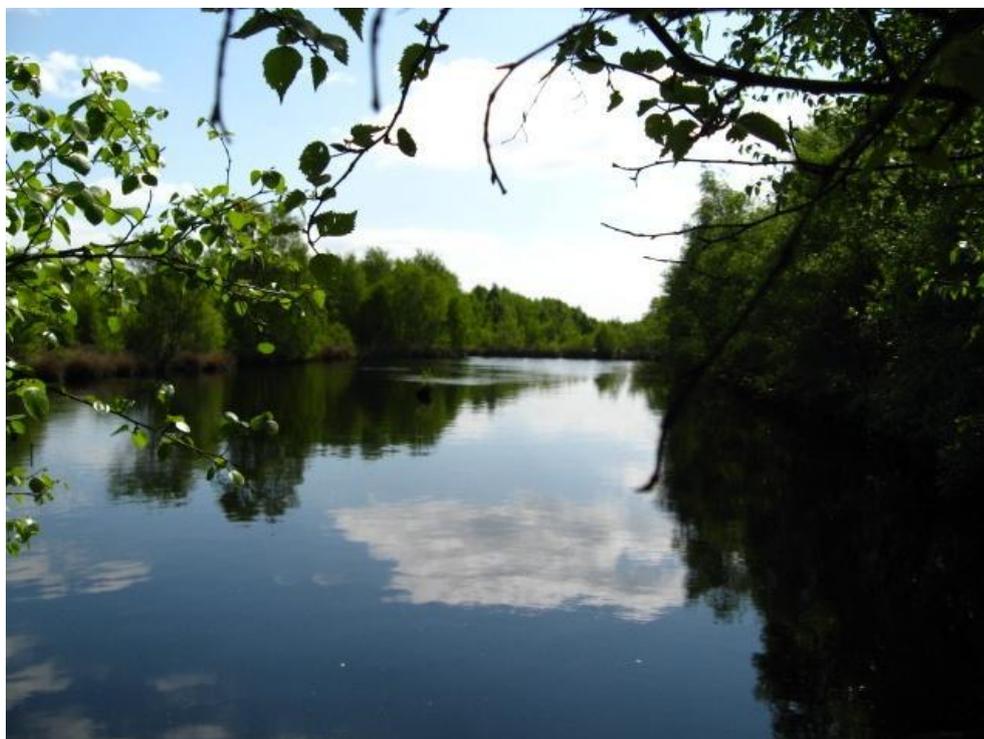
Figure 3-8 Pools of water at Ribbon Row

In Ribbon Row there are a series of connected ponds running from Medge Hall Tram to Poppleton's Moor (see Figure 3-8). These are deep and still and filled with dystrophic water in which there are no aquatic plants. The sides are steep and there is very little emergent or marginal vegetation, although a few clumps of soft rush are present.

In Ribbon Row there are a series of connected ponds running from Medge Hall Tram to Poppleton's Moor (see Figure 3-8). These are not natural features and were created by flooding of an excavated strip on Ribbon Row, through a number of stepped weirs. The height of the weirs has created deep water behind them which, due to its depth and dystrophic nature, has not been colonised by aquatic plants.

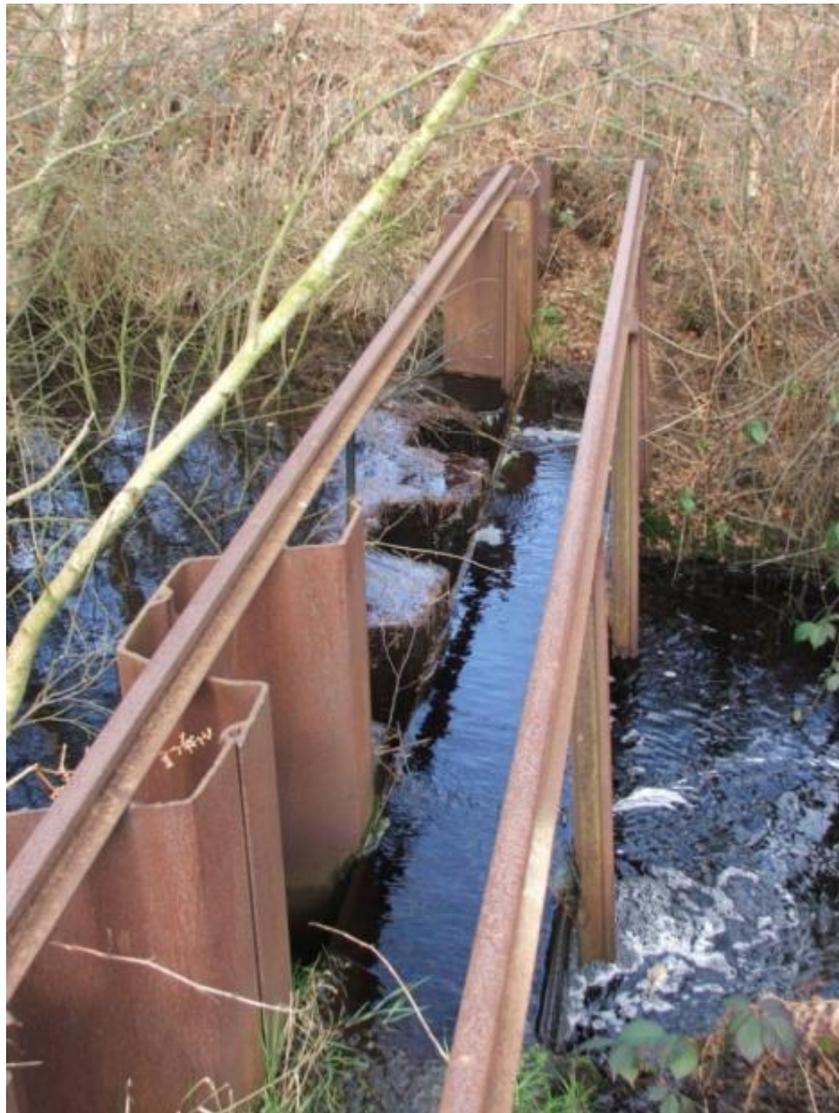
Figure 5-3 Balley Bridge Weir (NGR 474400, 414685)

The Balley Bridge Weir controls the level of water in Angle Drain before it discharges to the Swinefleet Warping Drain. It was constructed by Natural England. The weir here maintains a high water level within Angle Drain and Will Pitts Scrape. By maintaining a high water level in the drain, the rate of drainage from Pony Bridge Marsh is reduced, allowing a high watertable to be maintained (see section 7.1.1).

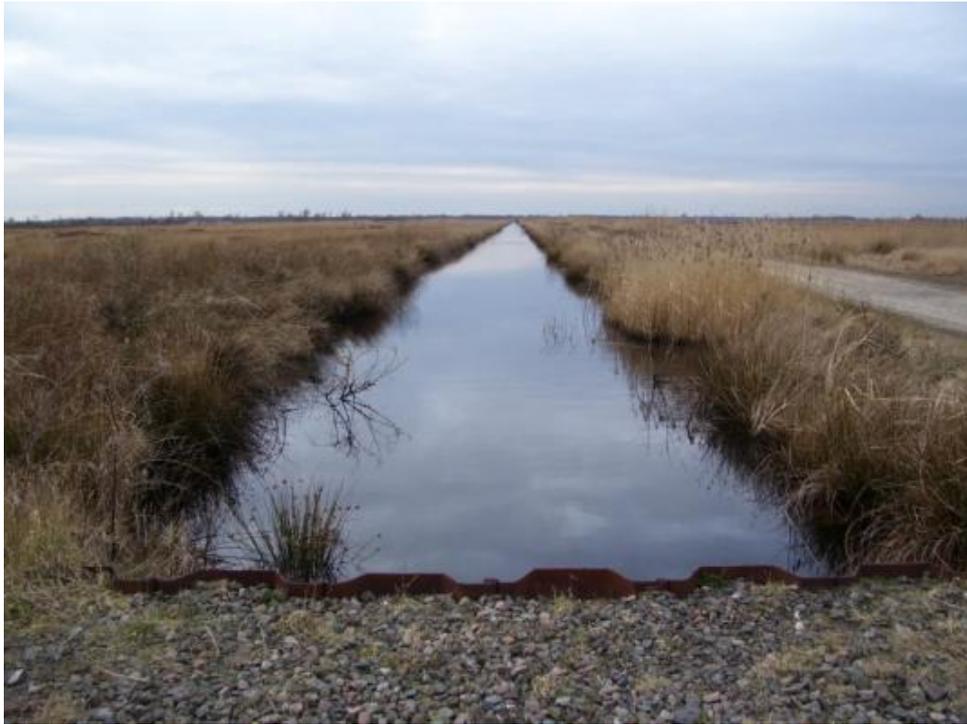
Figure 5-4 New Mill Drain Weir Looking Westwards

New Mill Drain forms the boundary of the Dutch Hand Graved Canals in the south of Thorne with the milled areas to the north. The drain flows eastwards and the weir is constructed at the point where the canals end and the drain continues east with milled areas both to the north and south. The weir maintains a higher water level within the drain and reduces the rate of drainage from the Canals area. Between the New Mill Drain and the milled area to the north lies the Limestone Road (AKA Fison's Road). This road is likely to reduce the influence of the drain on the water levels within the milled area.

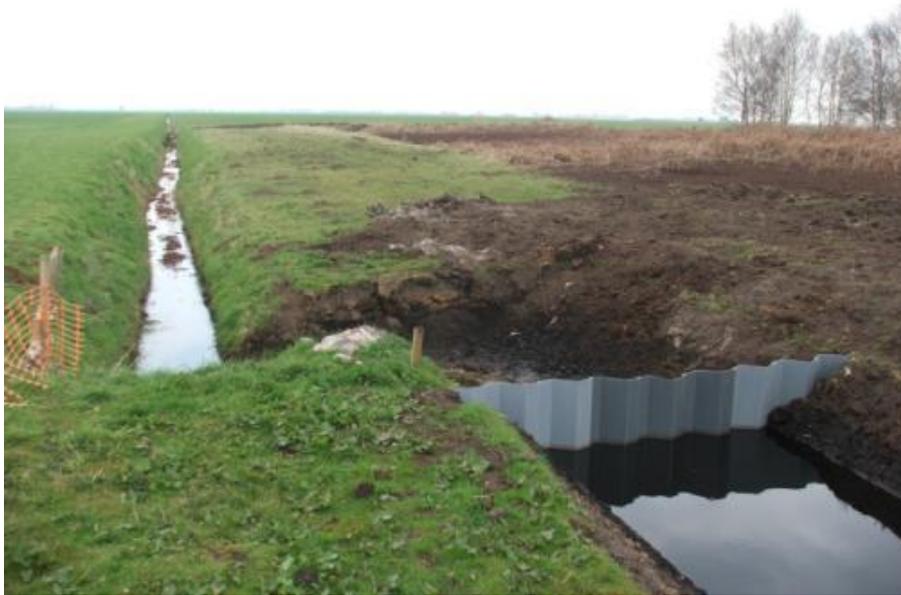
Figure 5-5 Plastic Pile Dam on the North Rand

This control structure is a plastic pile dam constructed on a drain which breaches the North Rand on Goole Moors.

Gauge board data collected as part of this study shows that, although the moor in this location lies lower than the agricultural land to the north, the hydraulic gradient is such that in winter water in this drain flows northwards from the moor.

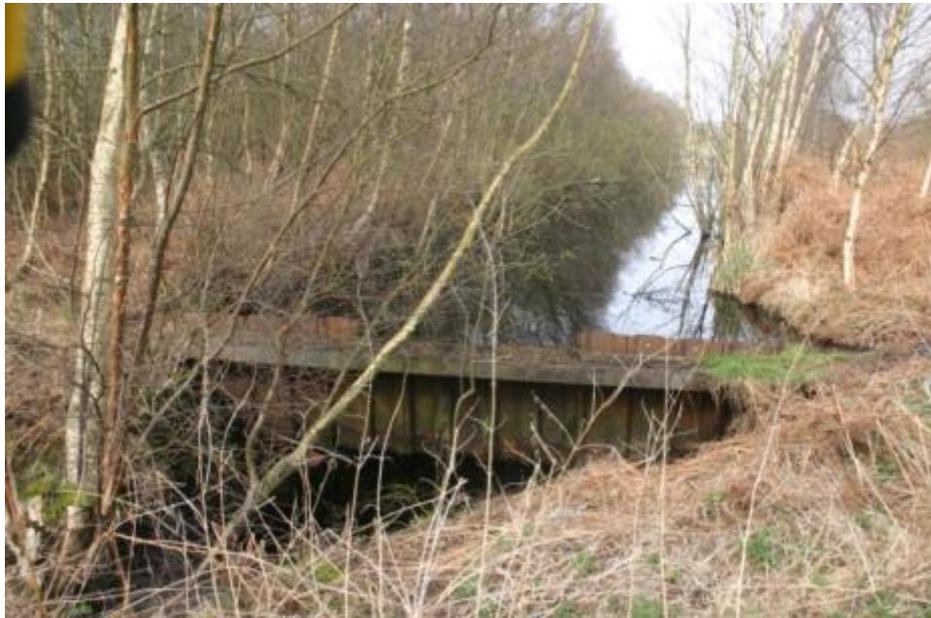
Figure 5-6 Steel Pile Dam at the Eastern End of Compartment 74

This structure is on the eastern end of Compartment 74 on Crowle Moors. It effectively blocks a large drain which runs straight into the peat mass. The compartments on either side show signs that the water level within them is too low (scrub encroachment), therefore, a review of the height of this structure may be required as part of the WLMP.

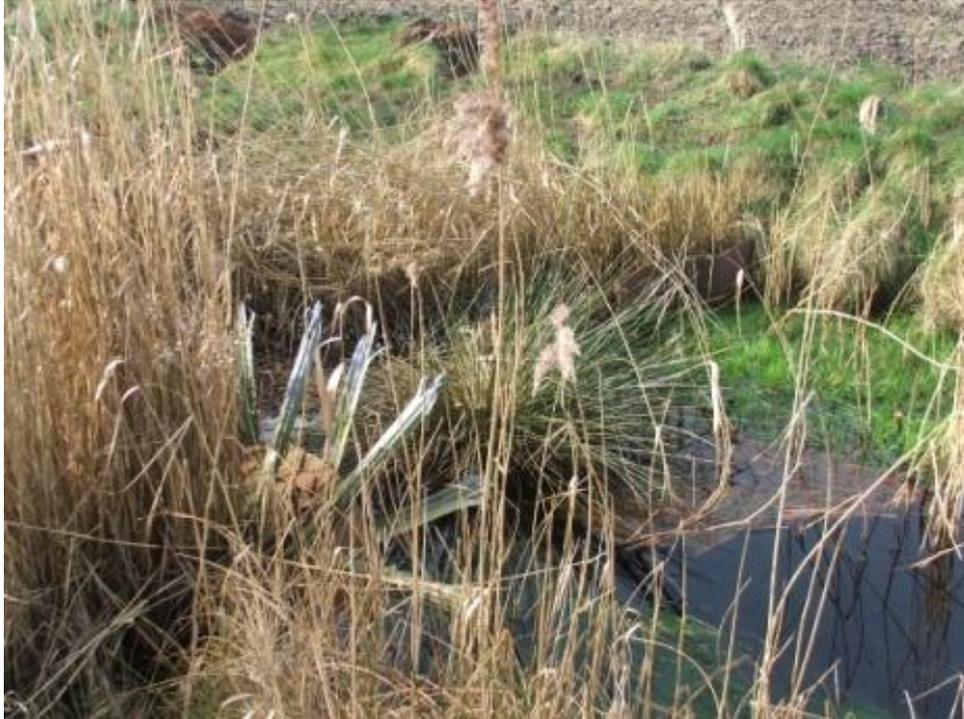
Figure 5-7 Control Structure on the Boundary Ditch South of Bell Pond (NGR 471343, 415390)

Along the eastern boundary of Thorne Moors between the Green Belt and Woodpecker Corner, there are a number of control structures on the drains which form the boundary (see Figure 5-7). These structures are set at a level beneath the top of the drains and are not always effective in keeping a satisfactory water level in the peat mass on site. This is usually because the drains have to be effective in draining the surrounding agricultural land, therefore, the water level in these can not be too high.

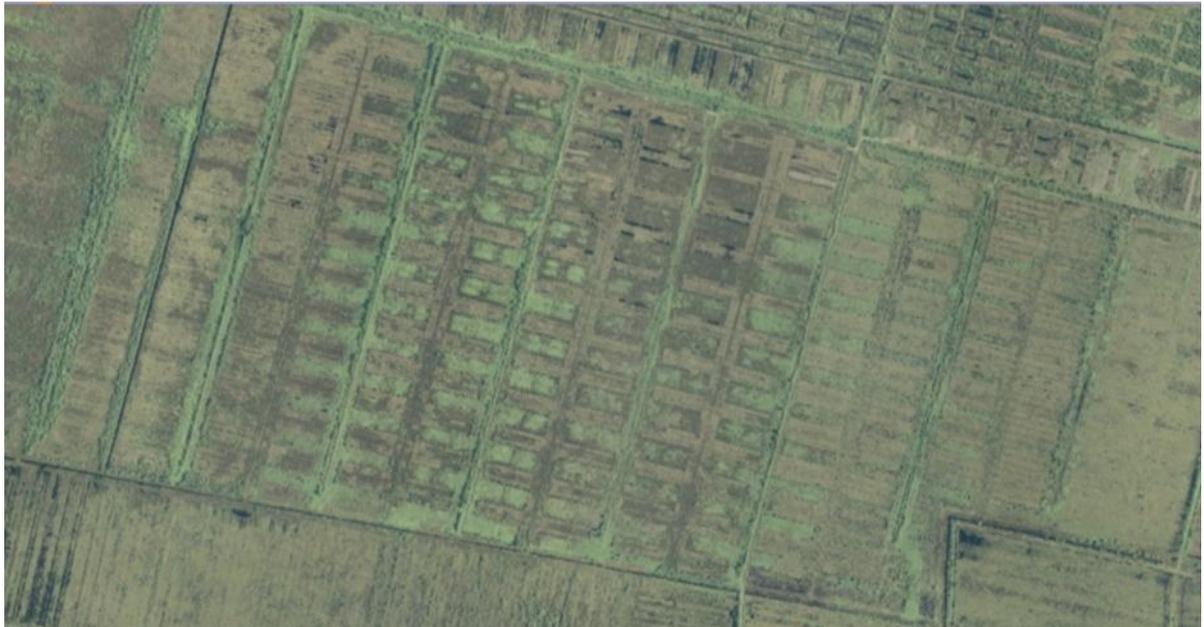
**Figure 5-9 Aerial Photograph of a Typical Area of Canal Workings
Showing the Comb-like Pattern (Natural England (C))**

Narrow deep linear drains bound the areas of the canal peat workings and there are no drains. Here there is a comb-like pattern of slightly higher ground surrounded by lower areas (the canals).

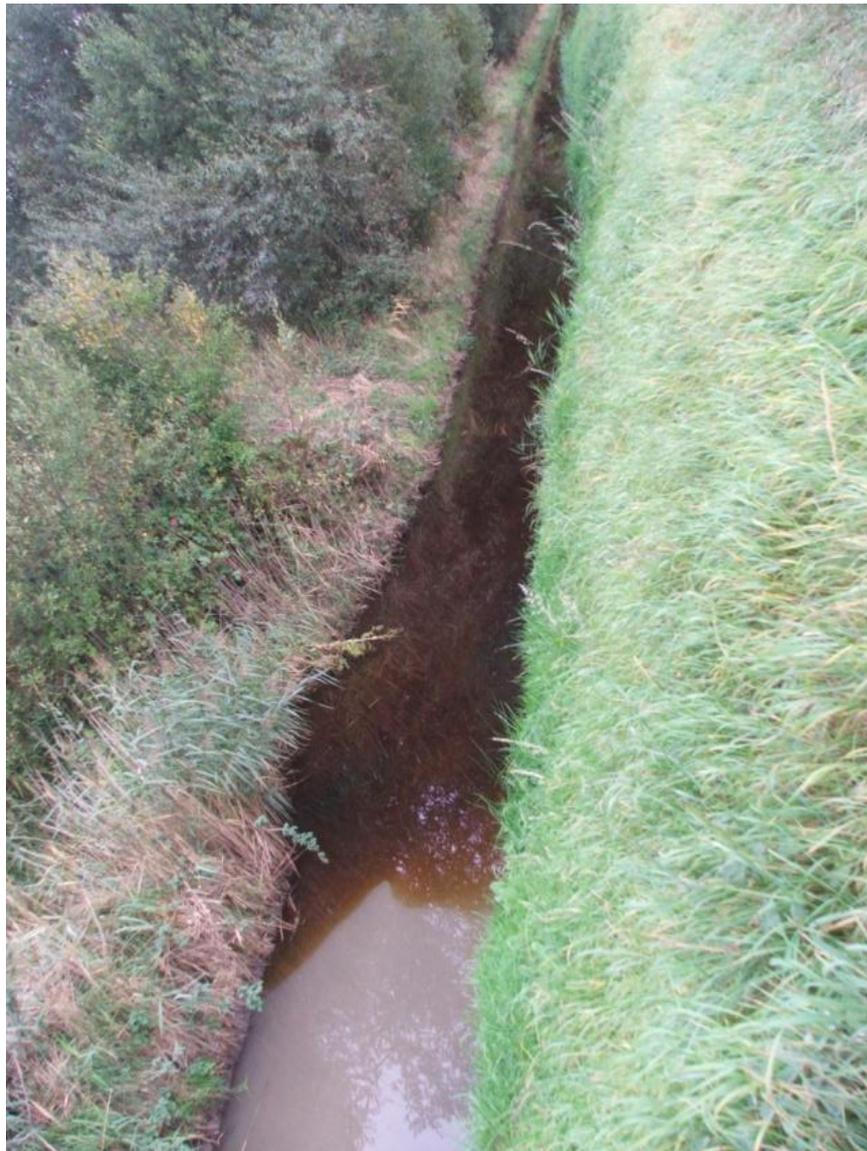
In most of the ditches on site the water appears to have a high Dissolved Organic Carbon (DOC) content, shown by the very dark, almost black colour (dystrophic). The source of the DOC is the surrounding peat, the degree to which the peat leaches carbon is likely to have increased with its degradation and draining. Figure 5-12 illustrates how the water on site differs considerably from the surface water surrounding it; the water from on-site has been stained by the peat and does not have the suspended mineral content of the surrounding drains.

Figure 5-12 External Drain Water from Thorne Waste Drain mixing with on-site water from Western Boundary entering from the left

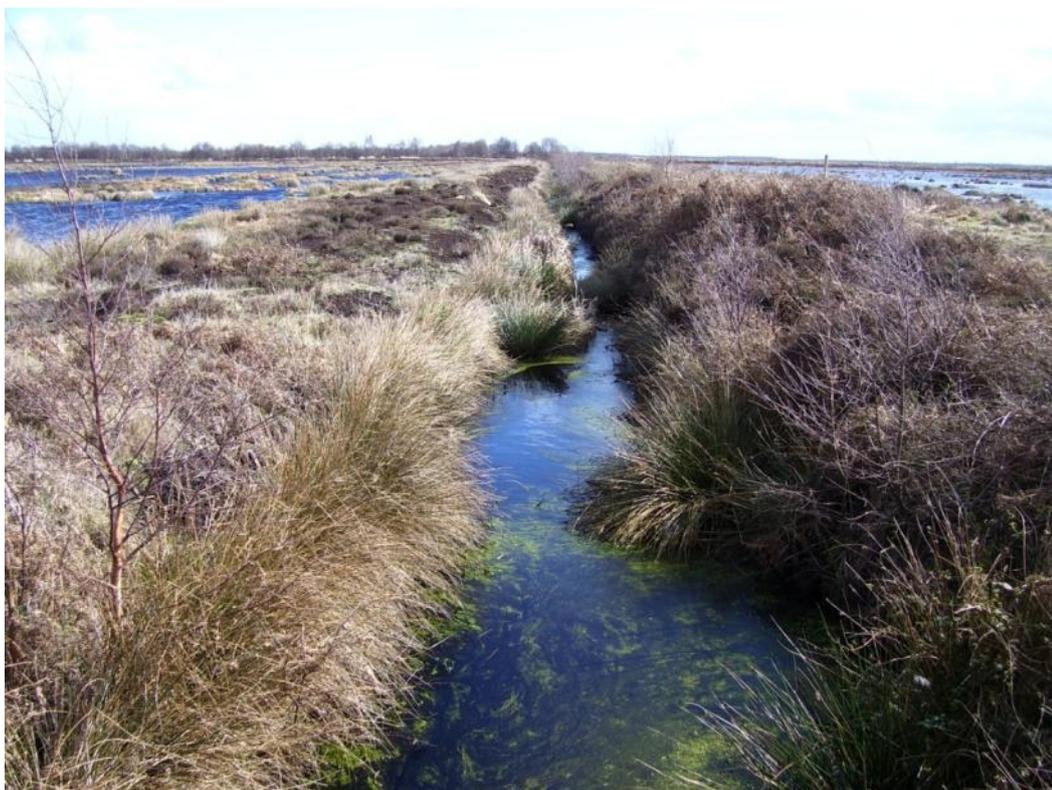
Figure 6-1 Photograph showing the small area effectively drained by ditches

Across large areas of Thorne Moors, notably in the milled area, the area drained by ditches and dykes can be quite small. Standing water in areas of cuttings, such as Unit 9, can be approximately 2 m higher than the water level in a ditch a few metres away (Figure 6-1).

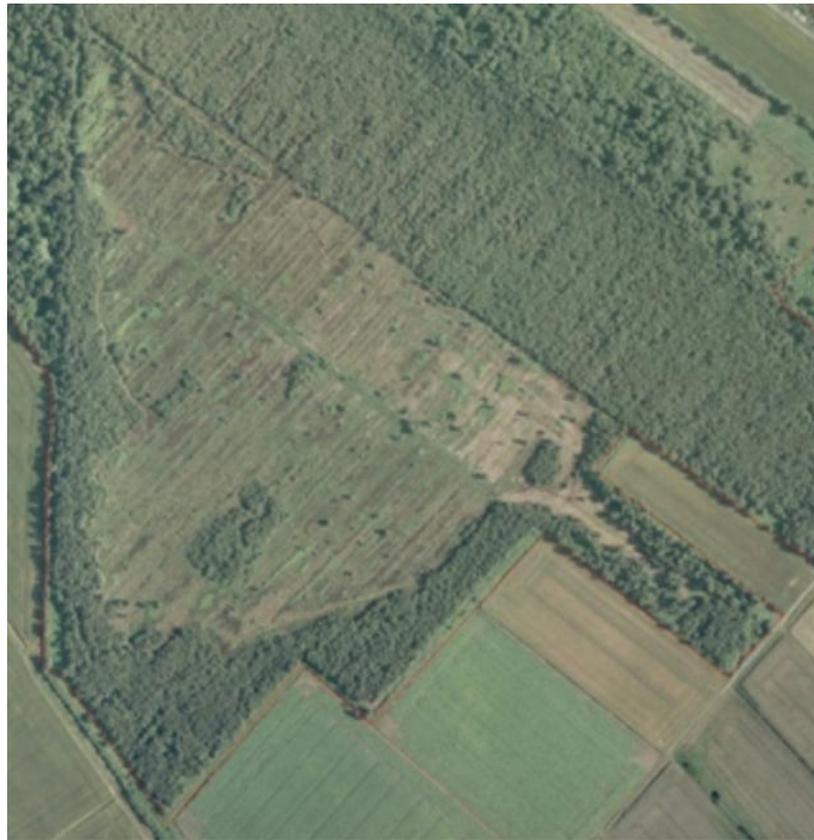
Figure 6-2 Woodland Edge of Flower Garden (Natural England 2009)

The variability in the parameters of the drains on site means that there are some locations where drains are effective at lowering the watertable in the peat mass. An example of this is the boundary drain at Flower Garden (South Crowle) where the drain has lowered the watertable sufficiently for woodland to establish in this area. Most of this has now been cleared by the Lincolnshire Wildlife Trust, however, there is still extensive woodland around the edge of the site (Figure 6-2 and Figure 6-3).

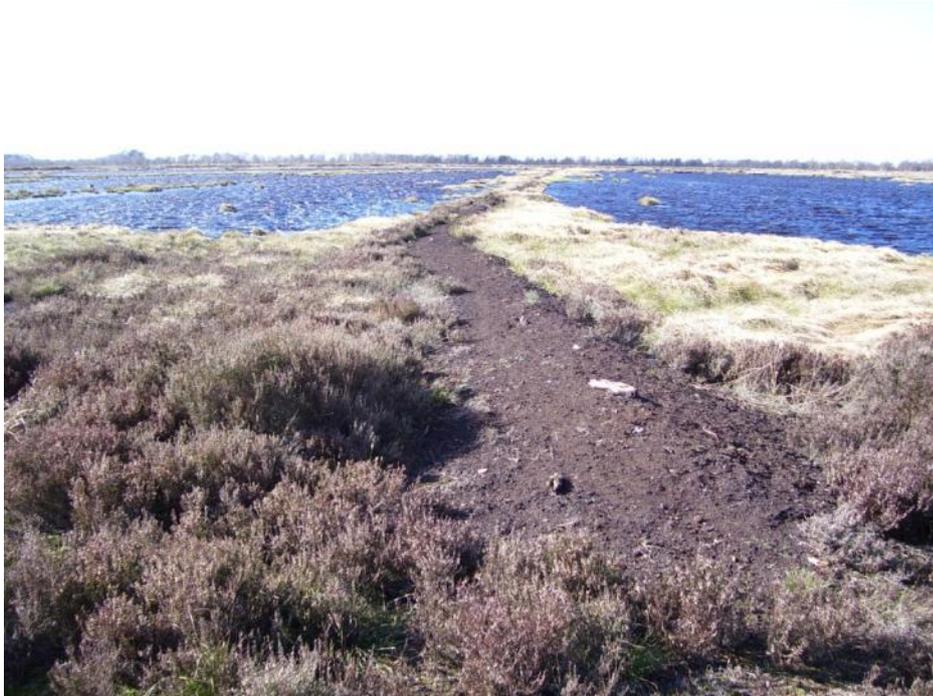
Figure 6-7 Bund Structure on a Milled Field (NGR 472049, 417797 looking West)

the agricultural land so water discharges from this location. In summer, when water levels are lower, it is likely that flows would reverse if the bund was not present. The break between NGR 4744380, 417185 and 474807, 417108 represents an area where the bund is thin or absent and a number of drains allow water to discharge off site. The southern boundary of the area is the higher hand cut peat which forms South Thorne. Ditch blocking in this area has reduced the amount of run-off the milled area receives from this section. The Swinefleet Warping Drain bounds the milled area to the east: this is a high level carrier drain constructed from low permeability clay, which hydraulically isolates it from the milled area (Figure 6-7).

Much of the milled area has been subject to the installation of a series of bunds as part of restoration works (Figure 6-7) (English Nature 2005). These bunds lie on the milled peat surface and act to impound surface water within cells (see Figure 6-7). The water level within the banded cells can be adjusted and controlled by pipes with adjustable angle outflows. In the winter, the cells are allowed to fill so that, on average, the depth of water within them is 30 cm above the peat surface. The aim is that this will stop the water level from falling beneath 20 cmbgl at the height of summer. The height of the water in the banded cells is controlled by adjusting the height of the pipes which cross the bunds. The water from these cells discharges through adjacent cells and eventually to the large drainages which have remained unblocked in the area.

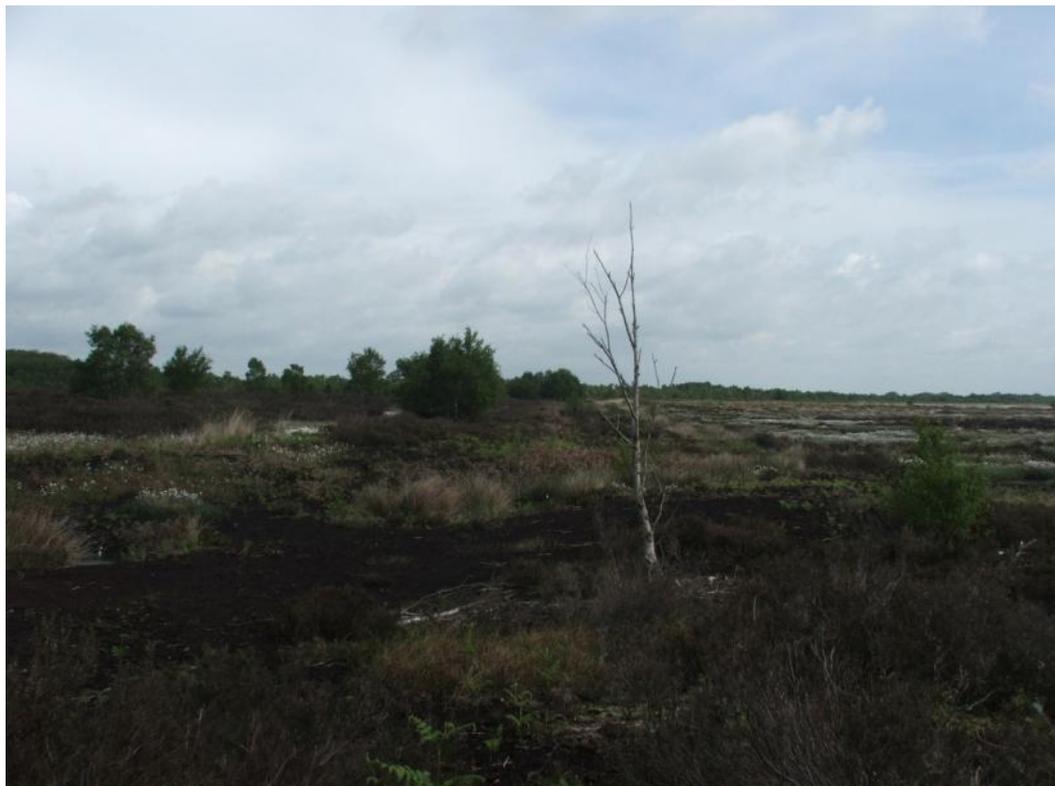
Figure 6-16 The North West Rand on Thorne Moors (NGR 470941, 417324)

Figure 6-16 shows the rand on the left, the interior milled surface on the right and the cliff separating them. It also clearly shows the full ditch on the rand (showed by the line of cotton-grass), perched higher than the milled interior surface.

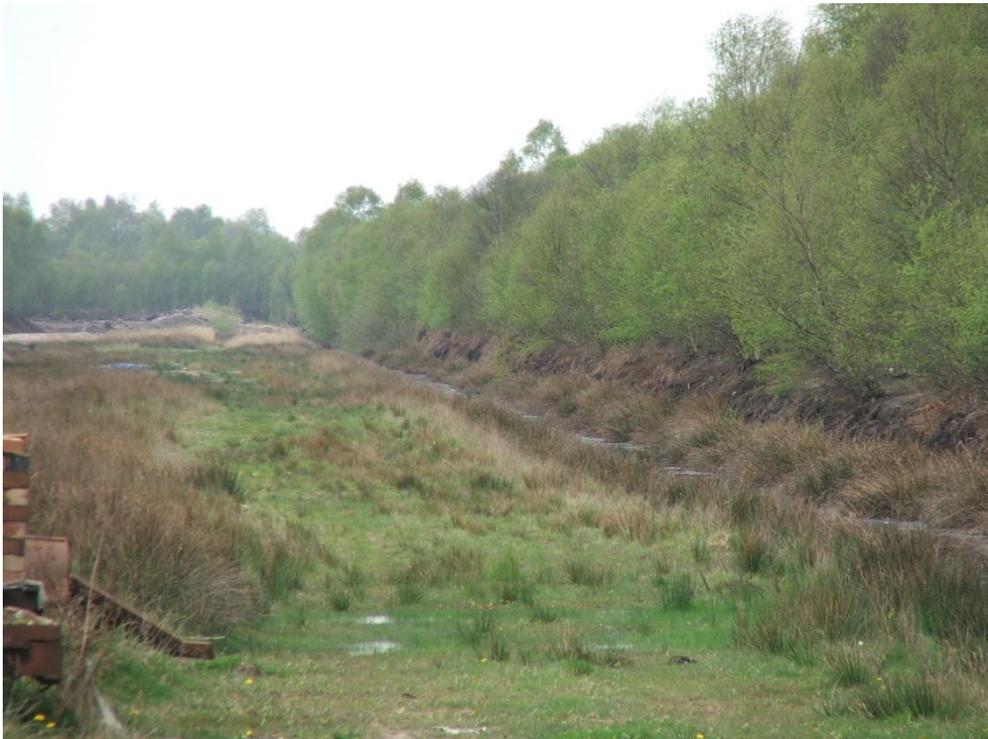
Figure 6-23 Peat Cliff on Ribbon Row, Crowle Moors.

The southern part of North Crowle is bounded by a 3 m tall cliff of peat produced through peat abstraction in the strip to the south (see Figure 6-23). This cliff drains the peat mass to the north. An approximate 25m wide strip along the cliff edge has been colonised by thick silver birch scrub, indicating the extent lowered watertable caused by the peat cliff. A borehole installed on top this peat cliff (CBH9 in Appendix B.1.1) shows a metre plus range in groundwater levels between the end of the summer low and the winter high level. In Figure 6-24, these levels have been plotted on a cross section of the peat cliff with a 1D model analytical model representation of the watertable. The model has been keyed into a level just above the summer low. This model indicates that the watertable begins to be within 25cm of the ground surface approximately 30m north from the cliff edge. This distance ties in with the colonised strip of birch along the cliff edge.

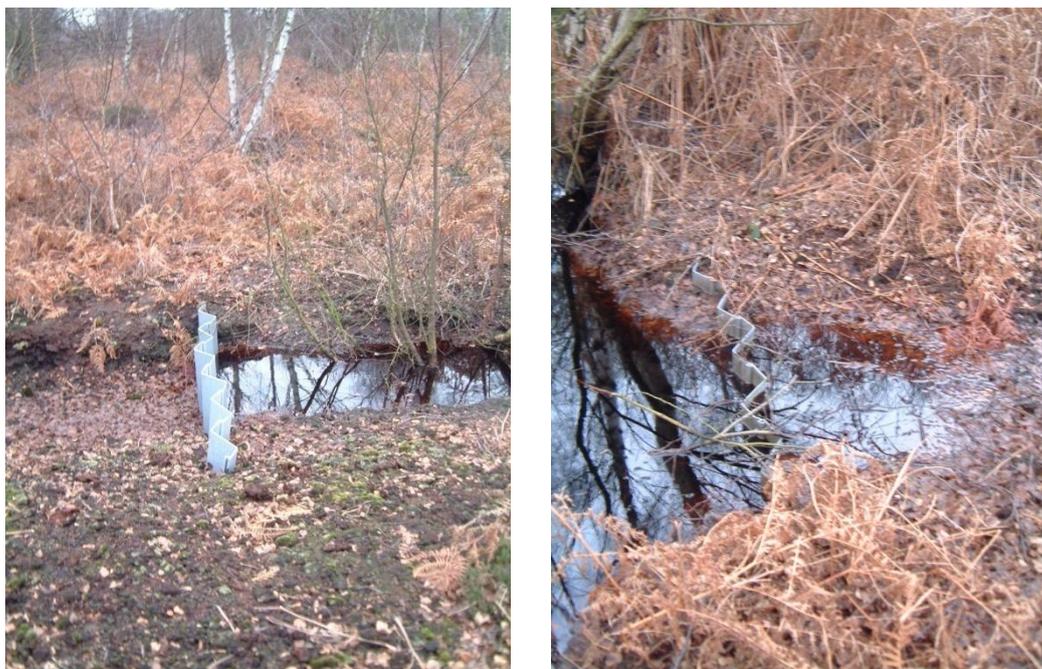
During site walk-overs it was noted that not all sheet pile dams were working effectively (see Figure 8-12). As part of restoration works, these structures should be examined and, where found to be deficient, they should be repaired or replaced.

Figure 8-12 Examples of sheet pile dams working (left) and not working (right)

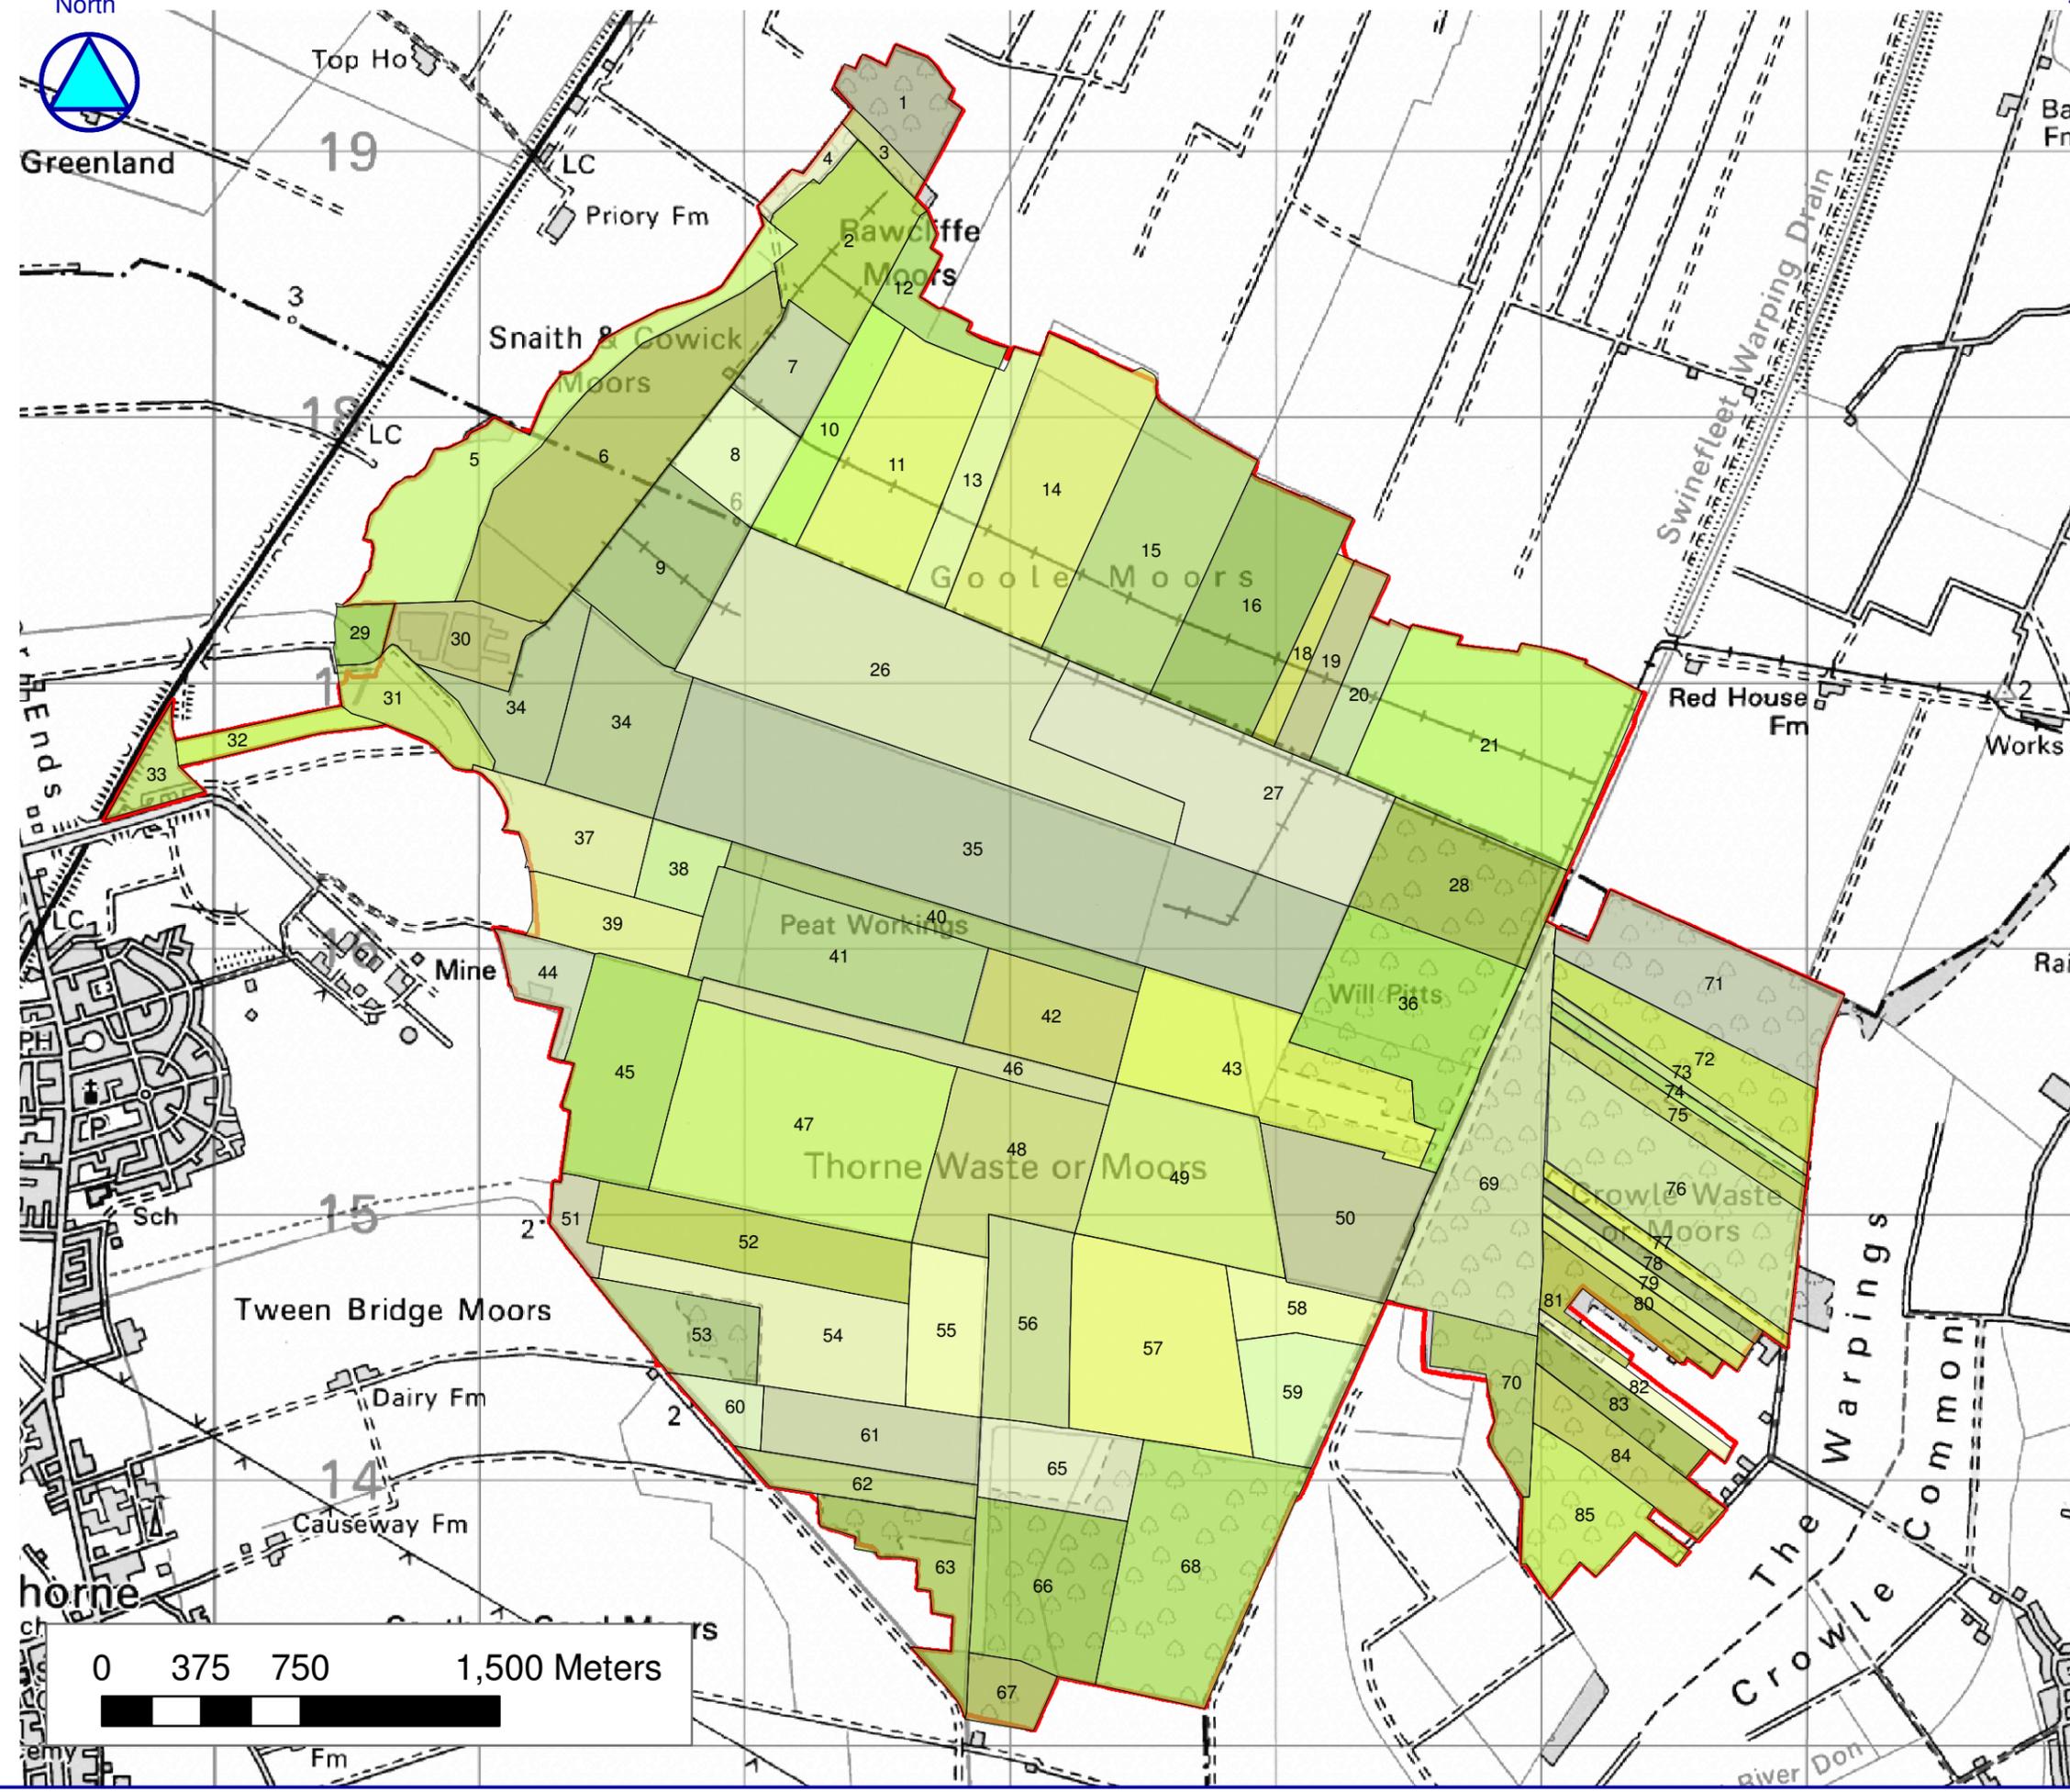
FIGURE A 1

SSSI Unit Classification
